# Arboricultural impact appraisal and method statement

Land at Beechlands Road, Medstead, Hampshire GU34 5EQ

Chris Allder MSc HNDArb FArborA MICFor RCArborA

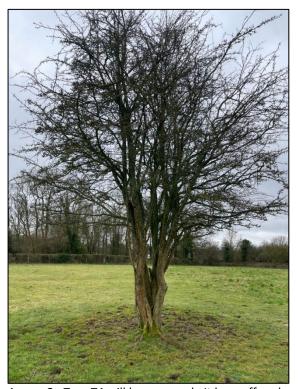
**Image 3:** Tree T4 will be removed. It has suffered extensive soil compaction, and livestock damage to the stem.

| Tree No | Species | Height<br>(m) | Diameter<br>(cm) @ 1.5<br>m | Maturity | Low<br>Branches | Category | Notes | Tree Works | RPA<br>Radius<br>(m) |
|---|---|---|---|---|---|---|---|---|---|
| T4 | Hawthorn | 5 | 37.5* | Mature | | С | Livestock damage | Fell | 4.5 |

| Brief operation summary | Trees affected | Location of detailed explanations |
|--|---|---|
| Tree felling and pruning: Contractor will carry out agreed works as described in Appendix 2. Will be completed before any significant site works begin. | Fell part of hedges H1<br>and H6, and trees T4,<br>T5 | Appendix 2 |

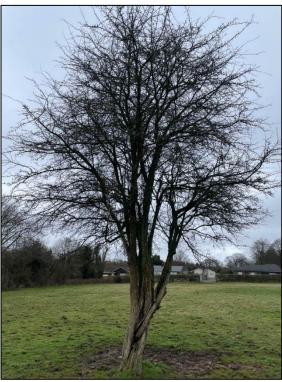
**Image 4:** Tree T5 will be removed. It has suffered extensive soil compaction, and livestock damage to the stem.

| Tree No | Species | Height<br>(m) | Diameter<br>(cm) @ 1.5<br>m | Maturity | Low<br>Branches | Category | Notes | Tree Works | RPA<br>Radius<br>(m) |
|---|---|---|---|---|---|---|---|---|---|
| T5 | Hawthorn | 5 | 32.5* | Mature | | С | Livestock damage | Fell | 3.9 |

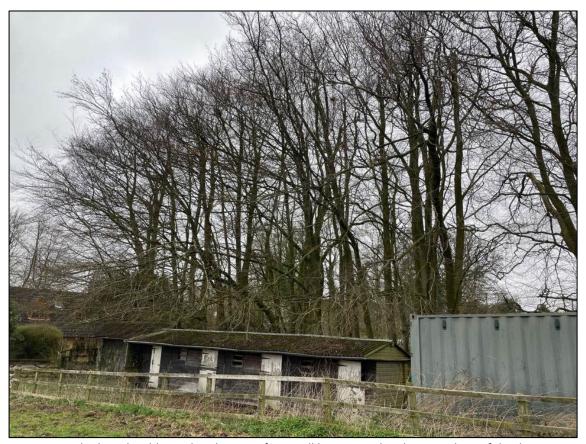
Several sheds/stables are to be removed. They will need to be demolished and removed taking care not to overly disturb any roots that may have grown beneath them. The area will then be retained as soft landscaping, ultimately of significant benefit to the trees. In summary, if the guidance set out in SGN 8 *Removing surfacing and structures in RPAs* is observed, we believe that the proposed works can be implemented without any long-term detrimental impact on tree health, and therefore local character.

Image 5: Sheds and stables within the RPA of G15 will be removed and returned to soft landscaping.

| Brief operation summary | Trees affected | Location of detailed explanations |
|--|---|---|
| Removing surfacing and structures in RPAs: These operations will be carried out as described in SGN 8. | G15 | SGN 8 Removing<br>surfacing and structures<br>in RPAs |
